# Explantation of 41-Year-Old Implants Following Primary Breast Augmentation

Maurice Y. Nahabedian, MD, FACS

**Abstract:** The long-term effects of primary breast augmentation is a topic of controversy. This case report will highlight the long-term outcome in a woman with Ivalon sponge breast implants and the reasons for explantation. The focus of the manuscript will include mammography, capsular contracture, and late hematoma.

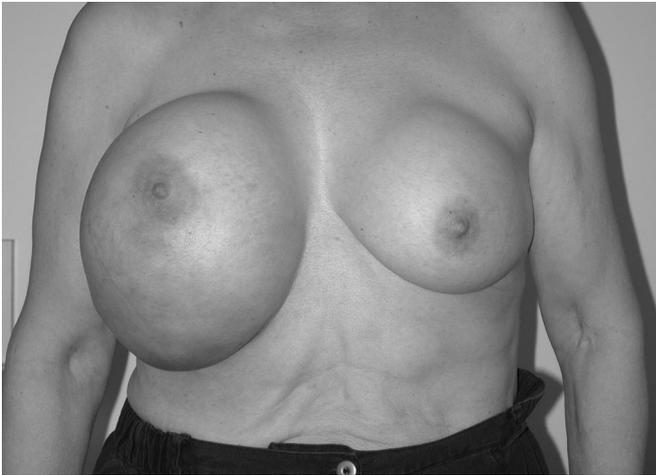
FIGURE 1. Preoperative photograph demonstrating enlargement of the right breast.

the enlargement, both breasts were firm, symmetric, and uncomfortable. Mammography had demonstrated capsular contracture without suspicious findings. Her past medical history was significant for diet-controlled diabetes mellitus, mild arthritis, and glaucoma. On examination, there was evidence of Baker 4 capsular contracture. The right breast was nearly twice the volume of the left (Fig. 1). The working differential diagnosis included malignancy, implant rupture, and fibrosis.

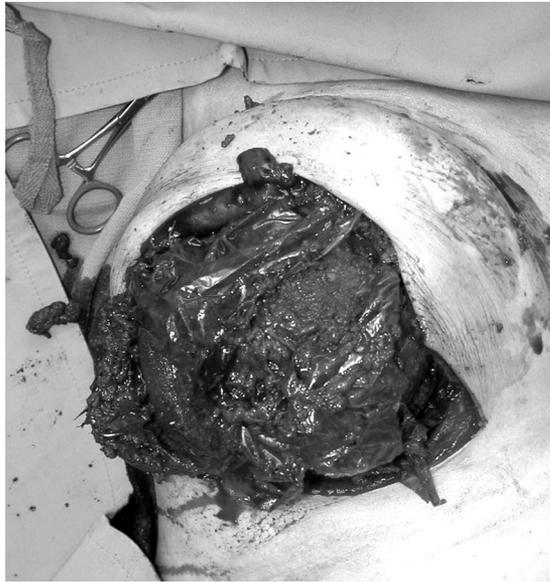
**FIGURE 5.** Intraoperative photograph of the right breast contents. There was a large amount of clot and serosanguinous fluid.

There were several reasons for removal of these implants; however, the principle reason was the late hematoma. The implants were not removed because of the capsular contracture or discomfort. Although the exact cause of the hematoma was uncertain, it was postulated that the calcified capsule caused the gradual erosion of an adjacent blood vessel. The phenomenon of a late hematoma is not new as

Operative findings of the right breast included an organized hematoma, serosanguineous fluid, and a thickened capsule approaching 1 cm in thickness (Fig. 5). A polyvinyl alcohol (Ivalon sponge) implant and its intact Silastic sheet envelope were removed (Fig. 6). Operative findings of the left breast include a thick fibrous capsule with an intact Silastic sheet and soft Ivalon sponge implant (Fig. 7). Following irrigation and total capsulectomy, the incisions were closed in an inverted "T" fashion on the right and a linear fashion on the left along the inframammary fold. Drainage tubes were inserted bilaterally. Pathology demonstrated marked fibrosis, chronic inflammation, and dystrophic calcification of the implant capsules bilaterally. No malignancy was identified.

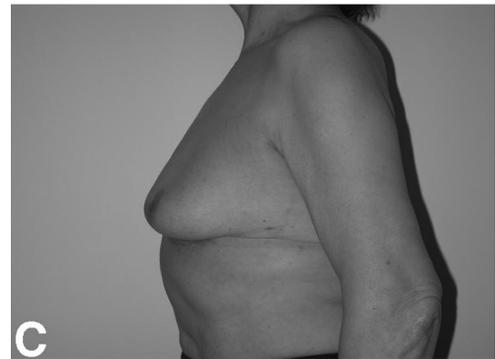
**FIGURE 8.** A–C, Postoperative views of the patient at 2-month follow-up. There is some contour asymmetry, and both breasts are soft and nonpainful.

Postoperatively, the patient did well. The drains were removed on postoperative day 6. The tissues were viable and the incisions were intact, without any signs of infection. The right breast demonstrated some skin distortion inferiorly. At 2-month follow-up, the breast contour had improved and the patient was pleased with the outcome (Fig. 8A–C).
